# New York State Department of Transportation

## Yellow Flag NB2358W012

**BIN: 1065318**

**Feature Crossed: 6TH AVENUE**

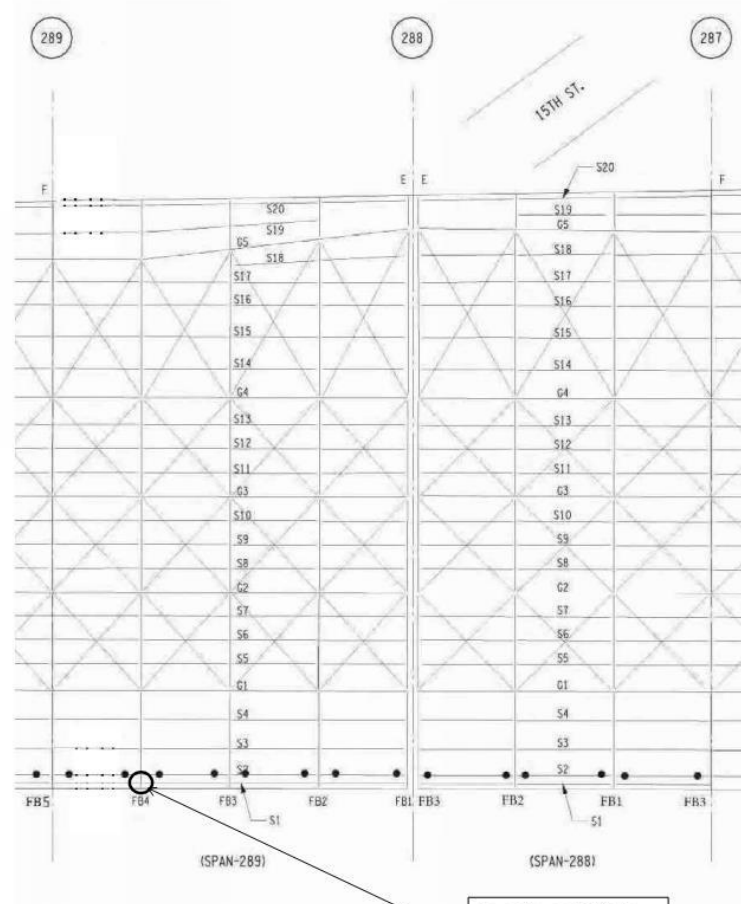
Photo Number: 2

Location of Yellow  
Flag NB2358W012**wsp****Attachment Description: Flag Location Plan**

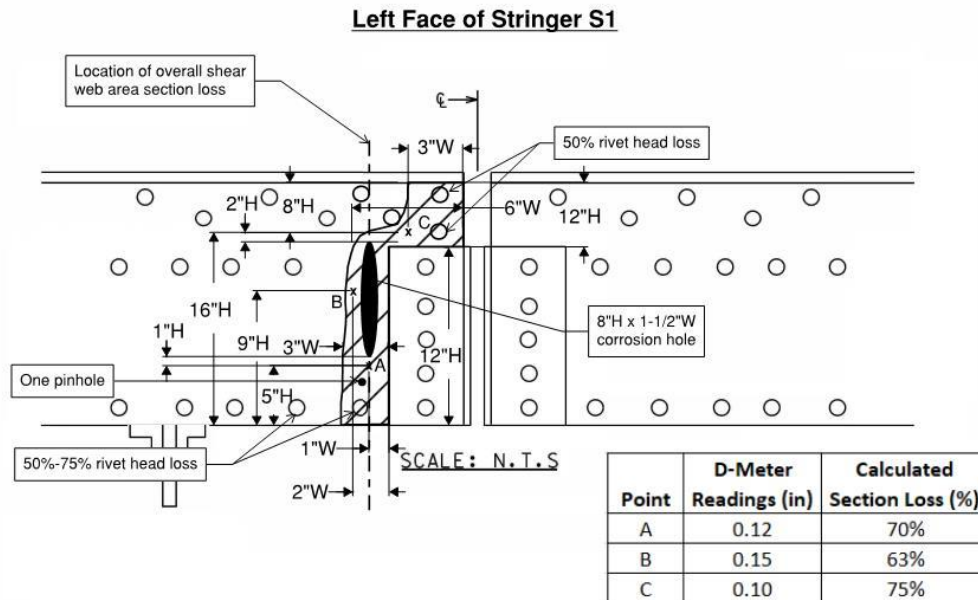
The end of Stringer S1 in Span 289 at the end side of Floorbeam FB4 exhibits severe section loss for the full height of the web along the connection angle with 0.10"-0.15" remaining thickness measured (RTM), resulting in approximately 63% to 75% section loss with average 70% section loss for full stringer web height. The stringer web exhibit one corrosion hole adjacent to the connection angle for 8"H x 1-1/2"W in the upper web with one pinole in the lower web. The overall shear web area section loss is approximately 57%. Four rivets at the left face of the stringer exhibit section loss for 50% in two rivets at the upper web and 50%-75% in two rivets in the lower web. (Photos #5 and #6) Both connection angles exhibit no significant defects. (refer to Flag Condition Sketch Photo #2 for more details)

Overall Shear Web Area Section Loss:

Shear web area:

$$(1''+5'') \times 0.12'' [\text{Point A}] + 8'' \times 0'' [\text{Corrosion hole}] + 2'' \times 0.10'' [\text{Point C}] + 8'' \times 0.40'' = 4.12 \text{ in}^2$$

Overall shear web area section loss:

$$((24'' \times 0.40'') - 4.12 \text{ in}^2) / (24'' \times 0.40'') \times 100 = 57\%$$

- As-measured web thickness is approximately 0.40".
- Stringer S1 is a steel channel member.
- Section Loss Calculations:
- Point A:  $(0.40'' - 0.12'') / 0.40'' = 70\%$
- Point B:  $(0.40'' - 0.15'') / 0.40'' = 63\%$
- Point C:  $(0.40'' - 0.10'') / 0.40'' = 75\%$
- Average Section loss:  $(70\% + 63\% + 75\%) / 3 = 70\%$

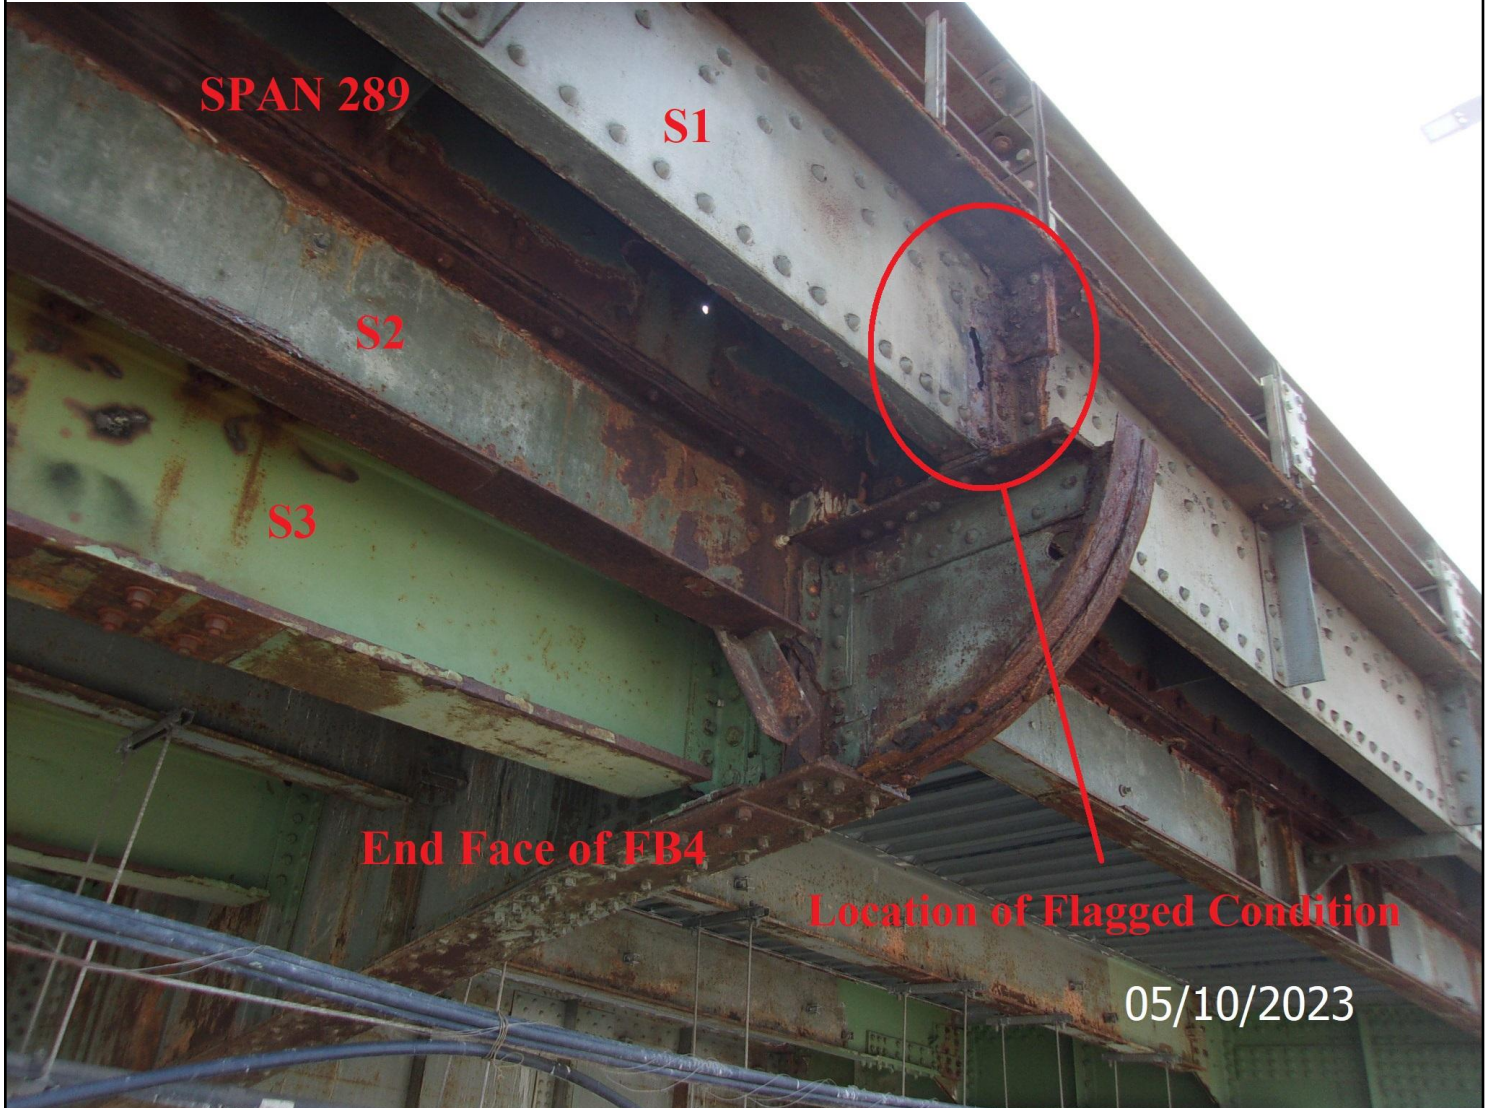
Photo Number: 3

**Attachment Description:** General view of the flagged condition at Stringer S1 at the end side of Floorbeam FB4 in Span 289. Looking Begin and Right.

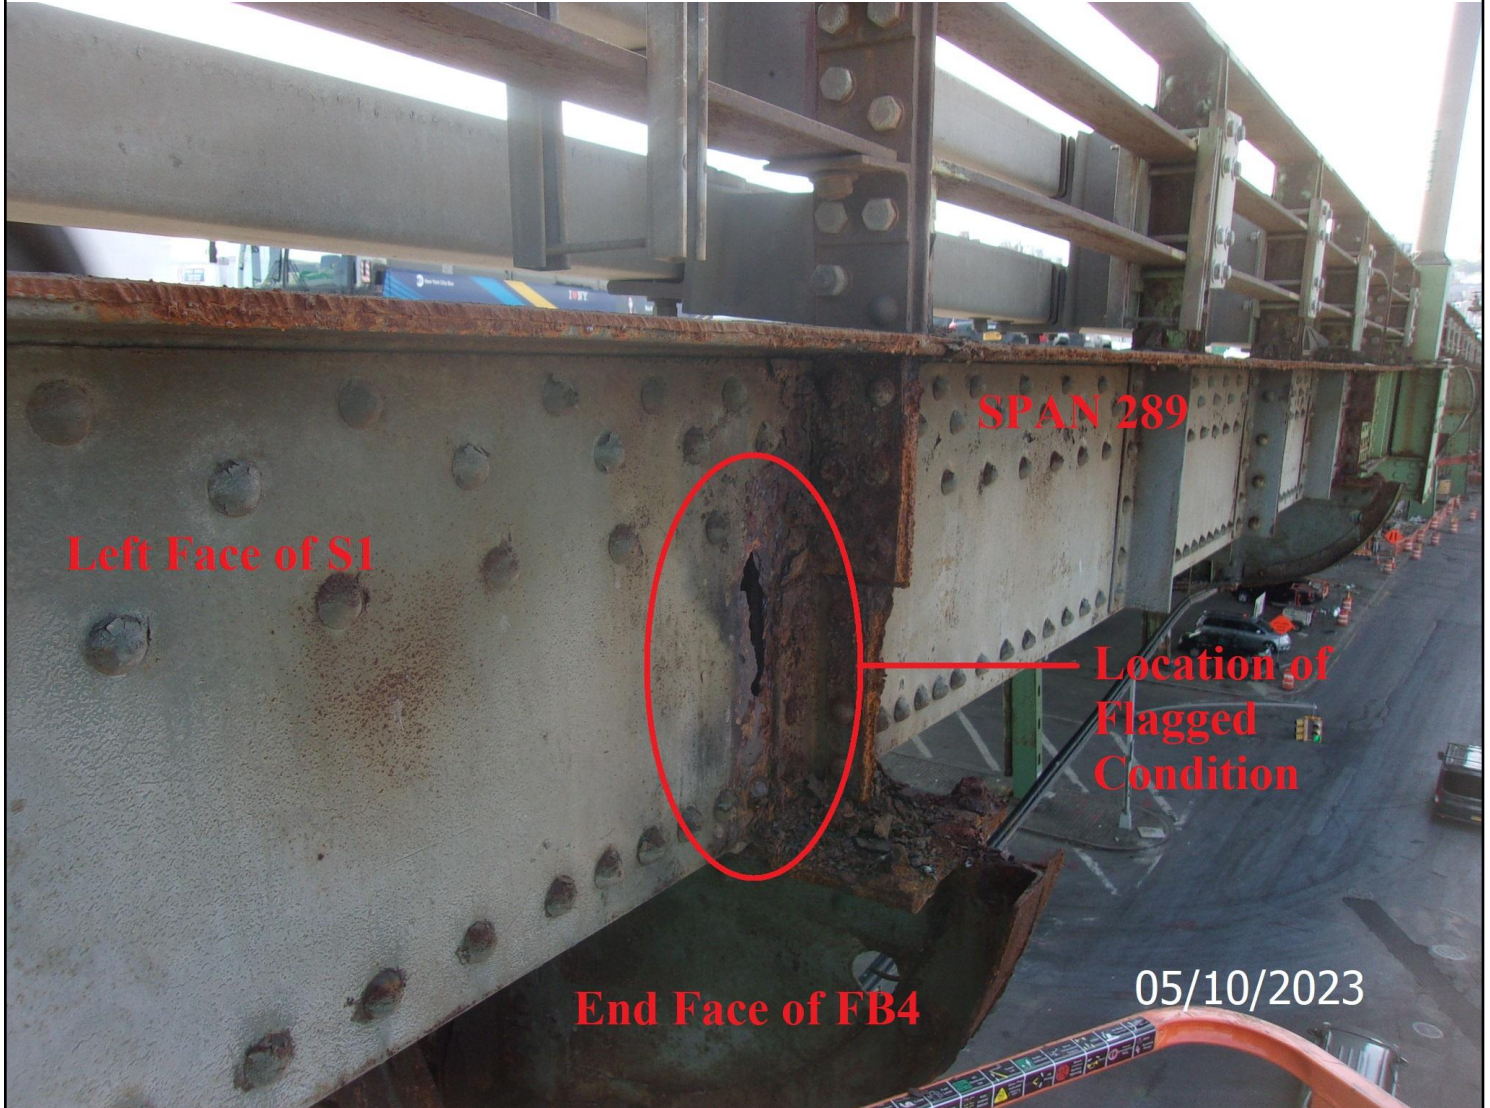
Photo Number: 4

**Attachment Description:** Close up general view of the flagged condition at Stringer S1 at the end side of Floorbeam FB4 in Span 289. Looking Begin and Right.

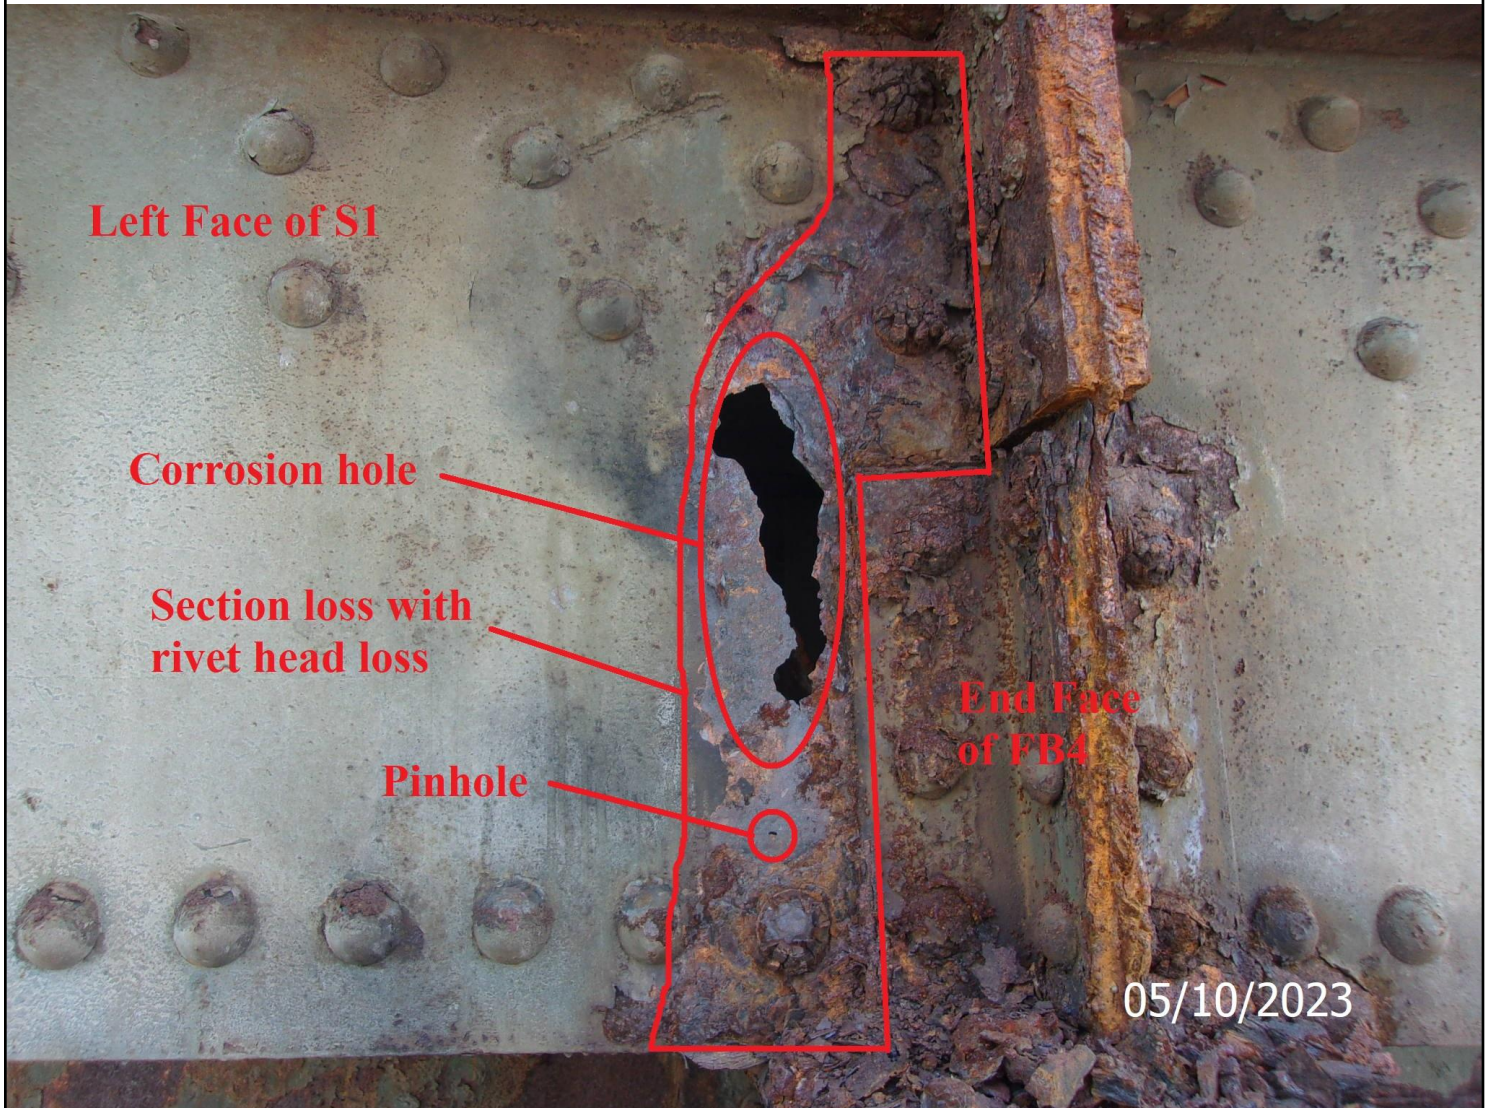
Photo Number: 5

**Attachment Description:** The left face of Stringer S1 at the end side of Floorbeam FB4 in Span 289. The stringer exhibits severe section loss with average 70% section loss for the full web height along the connection angle with one corrosion hole in the upper web and one pinhole in the lower web. Looking Right.

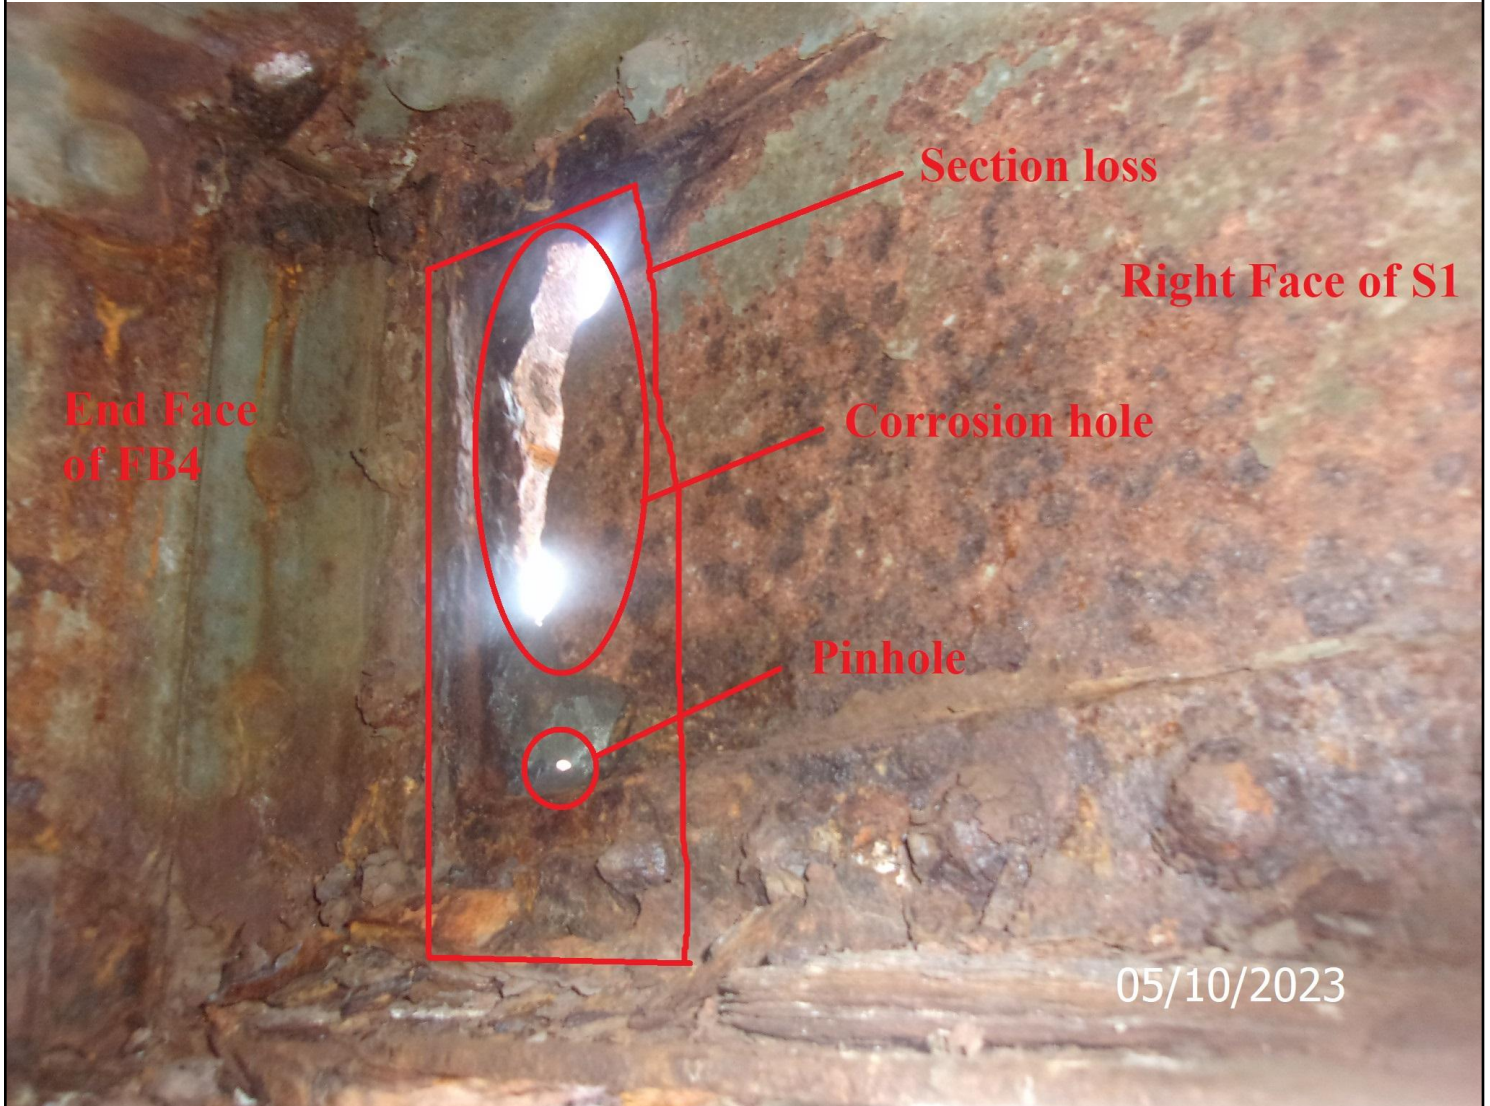
Photo Number: 6

**Attachment Description:** The right face of Stringer S1 at the end side of Floorbeam FB4 in Span 289. The stringer exhibits severe section loss with average 70% section loss for the full web height along the connection angle with one corrosion hole in the upper web and one pinhole in the lower web. Looking Begin and Left.
